Manhole Inspection Summary

Manhole # S11EE1018MH

Insp Date: **7/9/07 3:09 PM**

Location Address: **WABASH AVE**

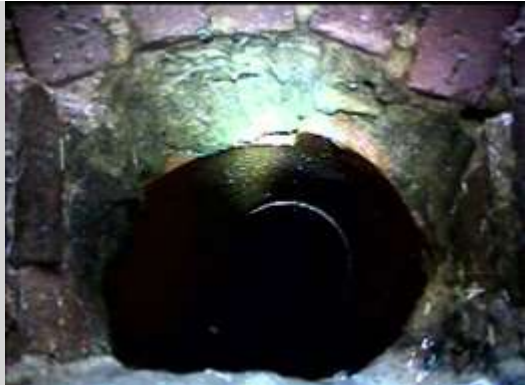
12 O'Clock Outflow

8 in. Circular Gravity Sewer
Pipe Out @ 12 O'Clock

Pipe Material: **Clay** ☐ Pipe Lined

Invert Depth: **10.28** (ft.) Flow Characteristics: **Fast**

Deposits: ☒ None ☐ Mud ☐ Sludge ☐ **Debris** ☐ Grease

Infiltration: **None** Pipe Seal Cond: **Sound**

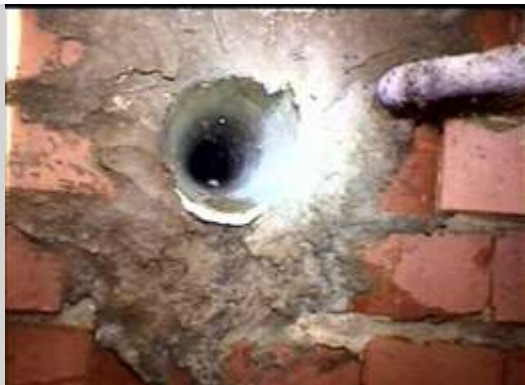
5 O'Clock Inflow

4 in. Circular Gravity Sewer
Pipe In @ 5 O'Clock

Pipe Material: **PVC** ☐ Pipe Lined

Invert Depth: **3.30** (ft.) Flow Characteristics: **None**

Deposits: ☒ None ☐ Mud ☐ Sludge ☐ **Debris** ☐ Grease

Infiltration: **None** Pipe Seal Cond: **Sound**

Connects To: **Out of Sewer Shed (No Info)**

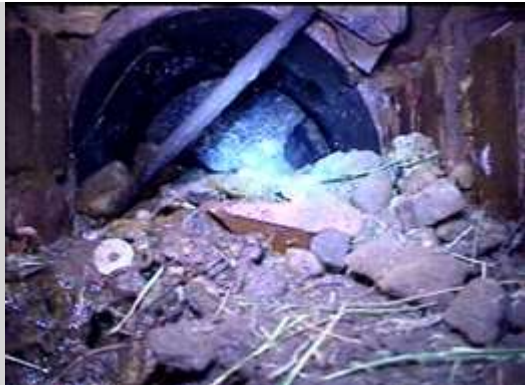
5 O'Clock Inflow

8 in. Circular Gravity Sewer

Pipe In @ 5 O'Clock

Pipe Material: **Clay** ☐ Pipe Lined

Deposits: ☐ None ☐ Mud ☐ Sludge ☒ **Debris** ☐ Grease

Silt Depth: **4** (in.) Deposits Extent: **Heavy**

Infiltration: **None** Pipe Seal Cond: **Cracked**

Connects To: **Stub connection / abandoned**

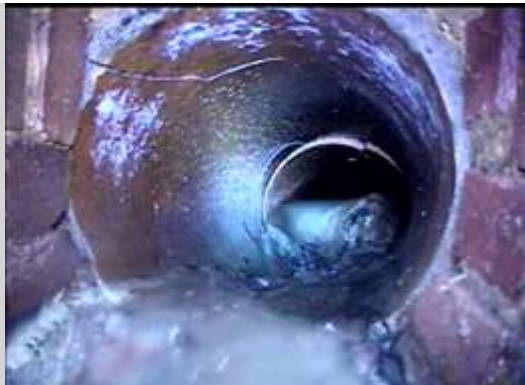
9 O'Clock Inflow

8 in. Circular Gravity Sewer

Pipe In @ 9 O'Clock

Pipe Material: **Clay** ☐ Pipe Lined

Invert Depth: **10.05** (ft.) Flow Characteristics: **Fast**

Deposits: ☒ **None** ☐ Mud ☐ Sludge ☐ Debris ☐ Grease

Infiltration: **None** Pipe Seal Cond: **Cracked**
